Building Abstract

Main Building

Building 2

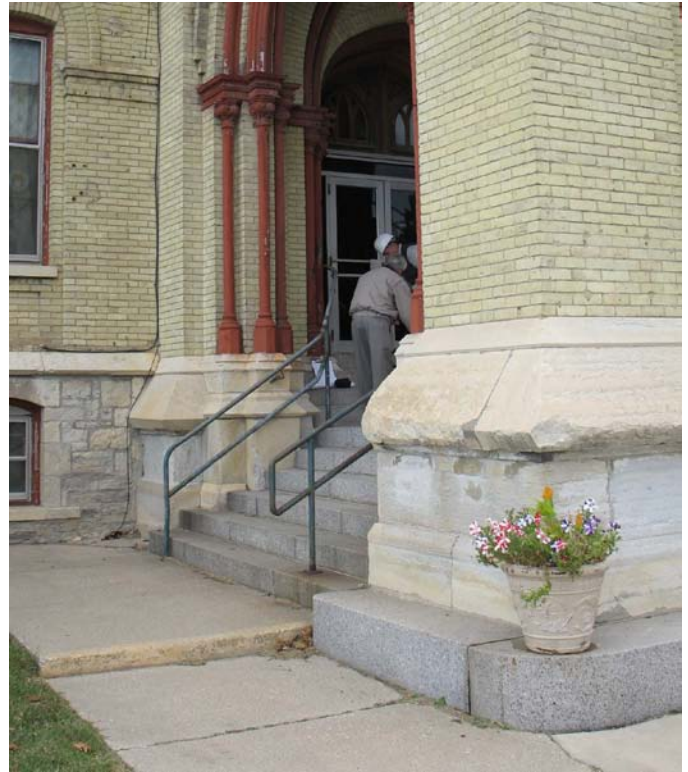
1 Dirt and pollutants on stone foundation wall.

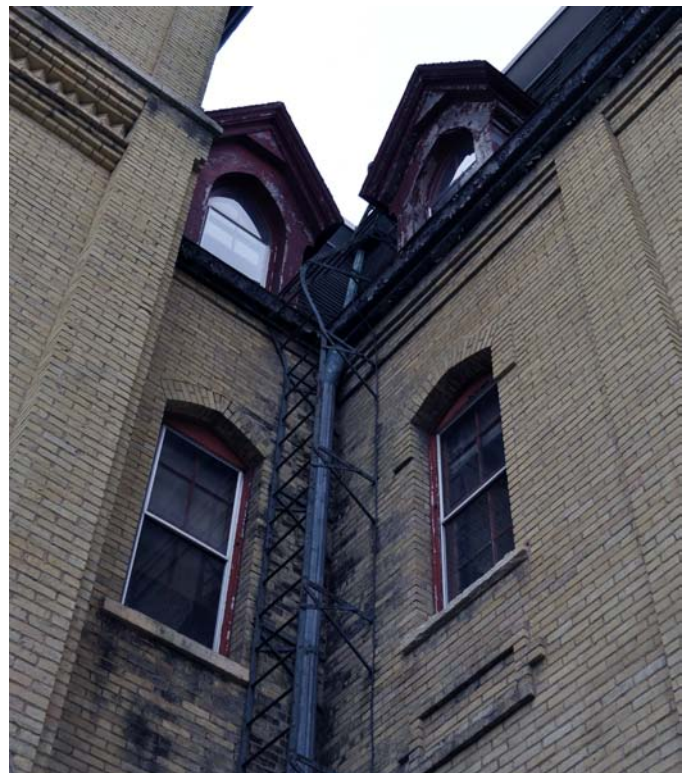
7 Spalled stone trim and lintel. Loose electrical cable. Peeling wood dormer.

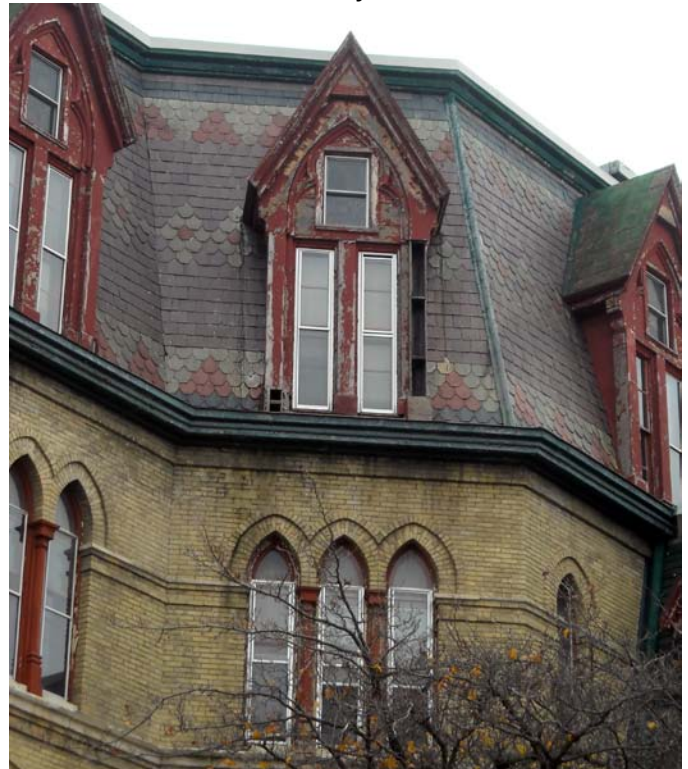
11 *Damaged asphalt shingles. Inappropriate slate replacement. Paint peeling at dormers. Deteriorated tin roof. Inappropriate roof coping material.*

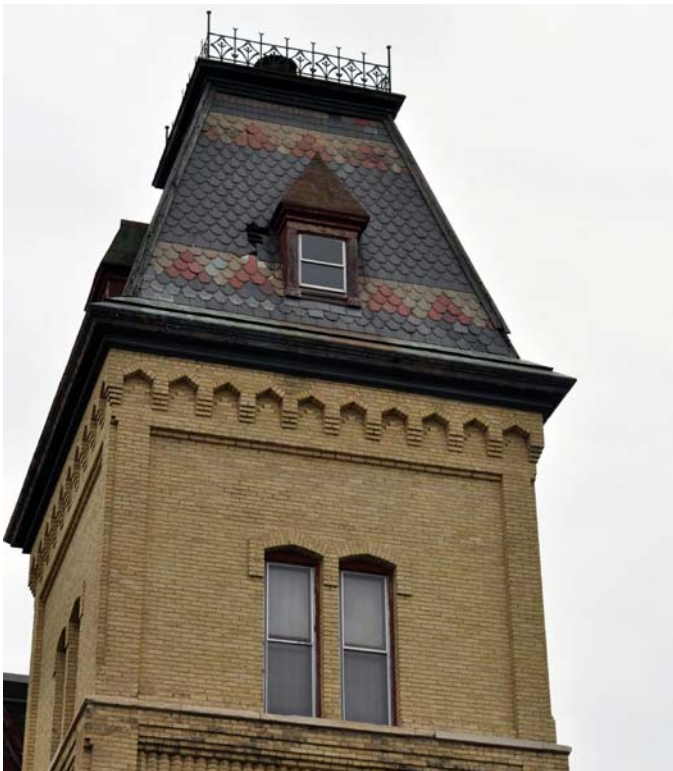
12 *Deteriorated wood dormer. Peeling paint. Stained bricks. Inappropriate roof coping material.*

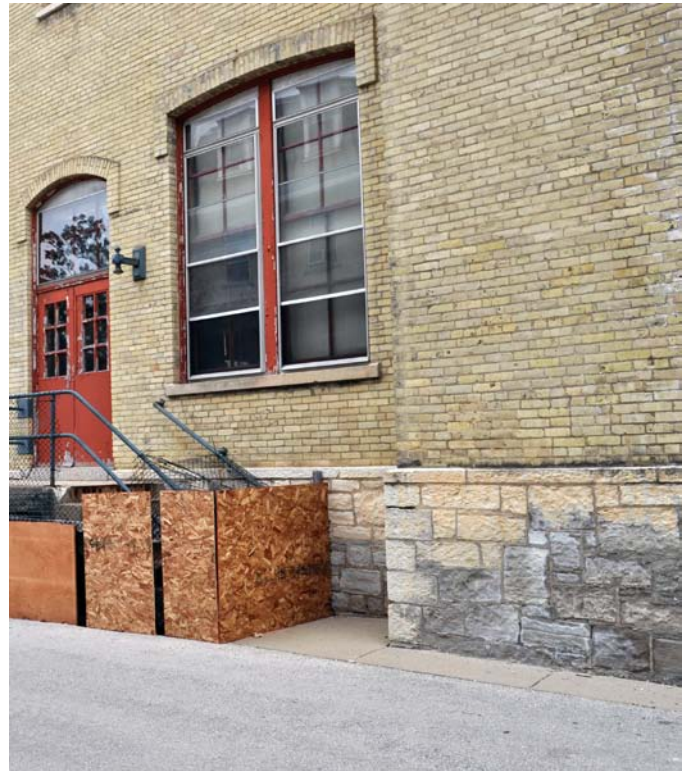
19 Vegetation and stains on masonry walls. Efflorescence on brick wall. Inappropriate window infill.

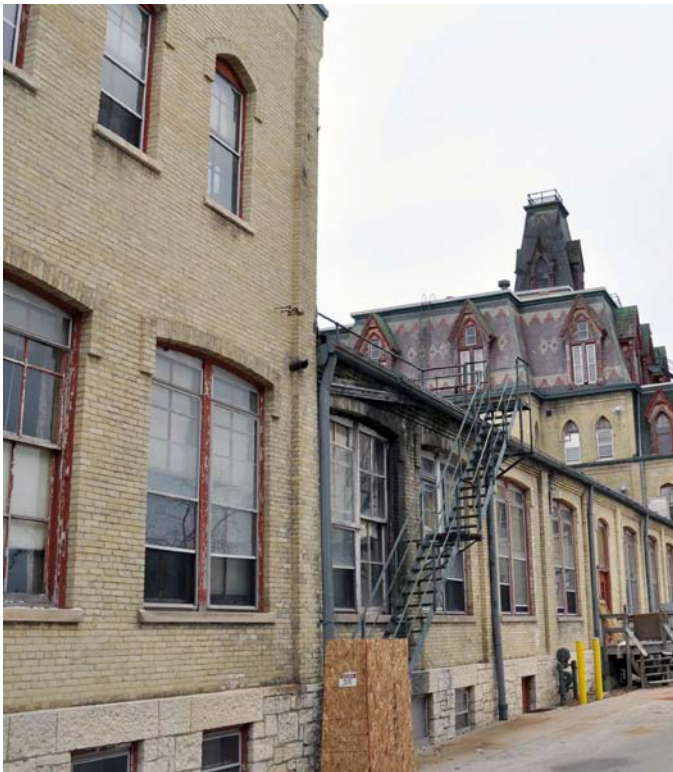
20 Efflorescence and stains on masonry walls. Broken light fixture. Peeling paint. Inaccessible entry.

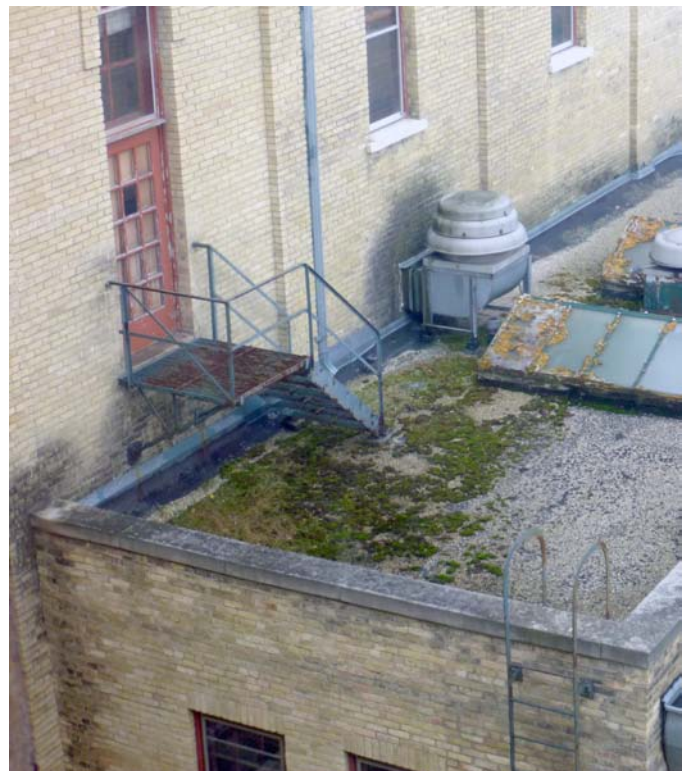
23 Deteriorated gutter. Deteriorating fire escape stair. Stains on brick wall. Missing brick mortar.

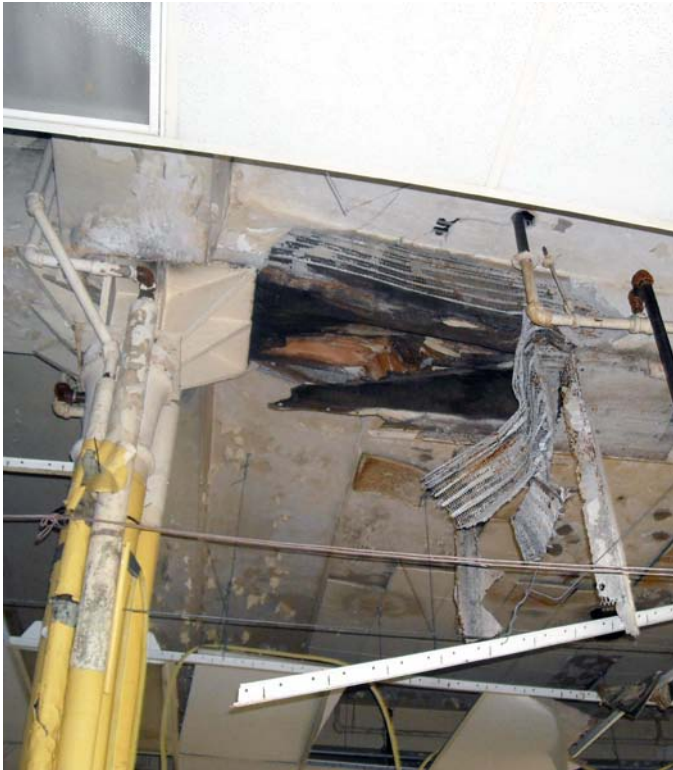
28 Peeling paint. Acoustical tile over plaster ceiling.

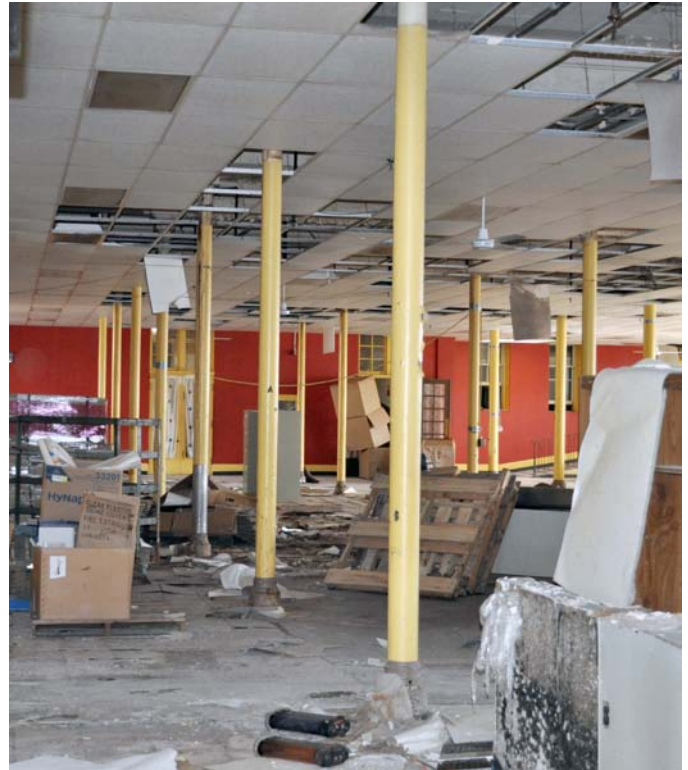
29 Water infiltration. Damaged plaster and acoustical ceiling. Peeling paint. Mold, dirt, and pollutants.

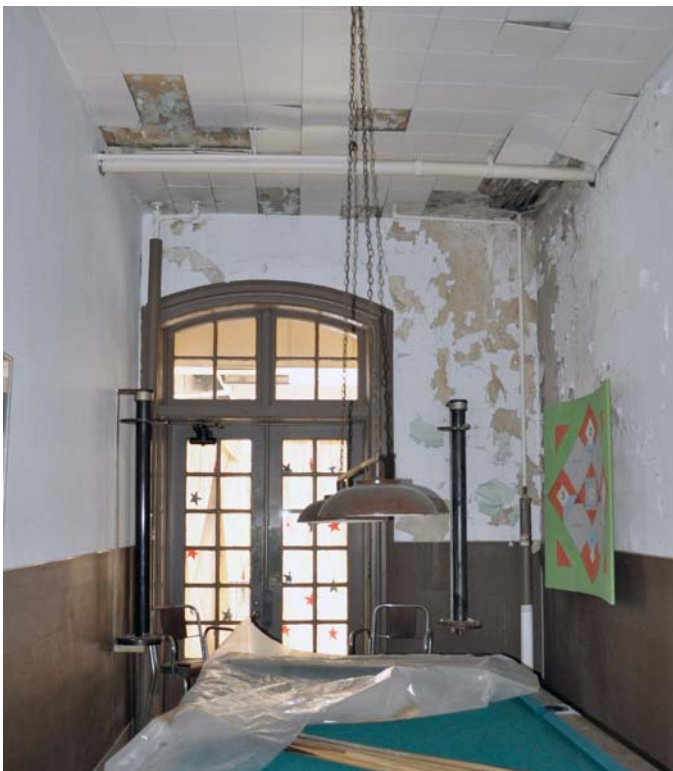
30 Water infiltration. Missing and damaged acoustical ceiling. Mold and pollutants. Damaged resilient tile floor.

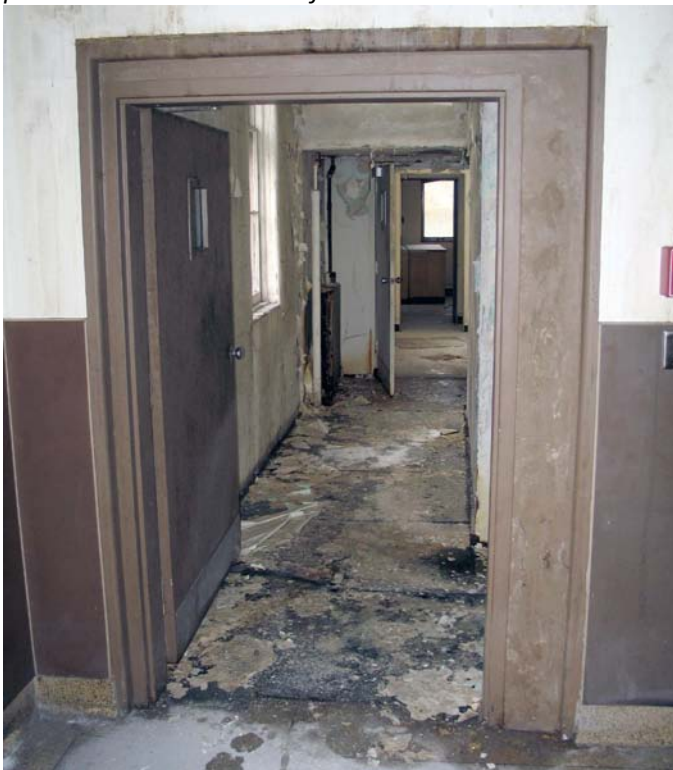
34 Mold, dirt, and pollutants on walls and floor. Vinyl wall covering and vinyl wall protection panels.

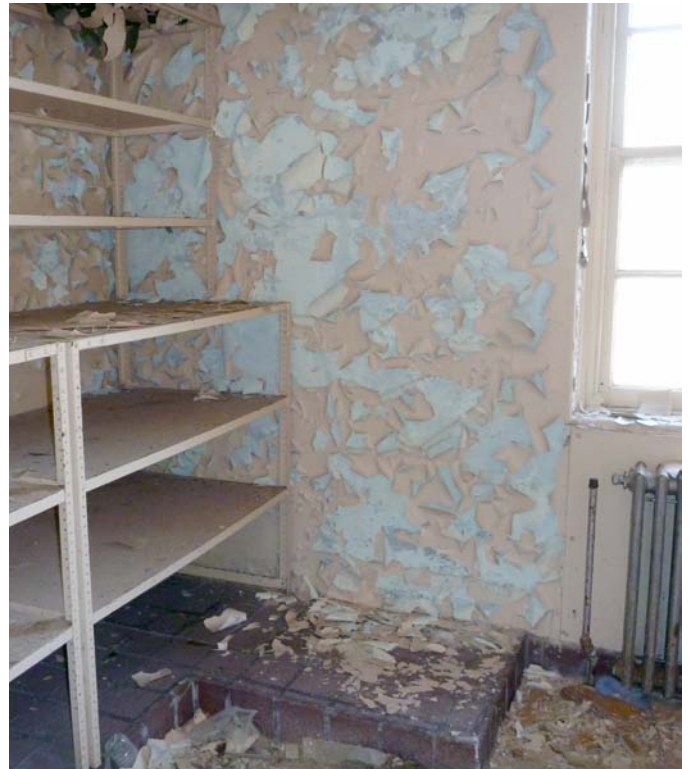
39 Peeling paint on walls, ceiling, ductwork and hood.

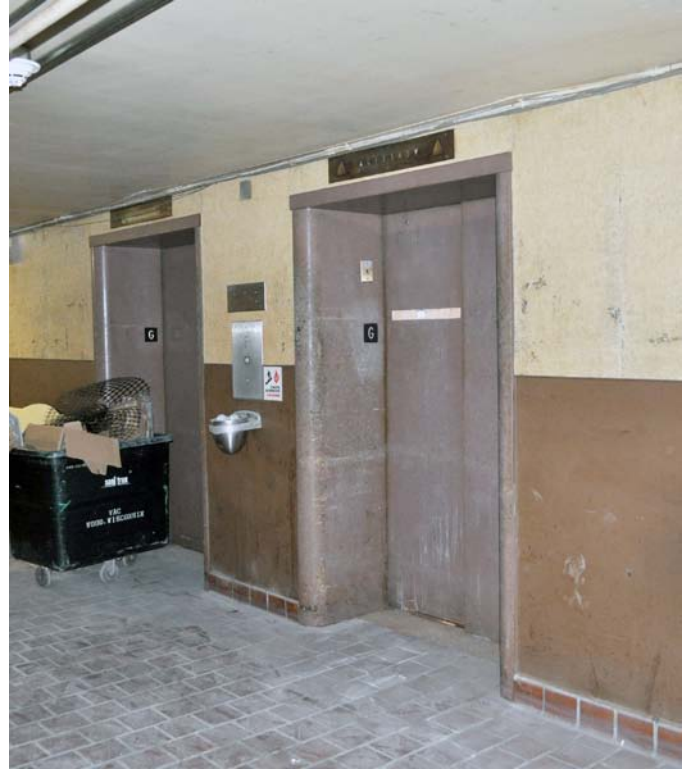
45 Water infiltration through foundation walls. Deteriorating plaster wall.

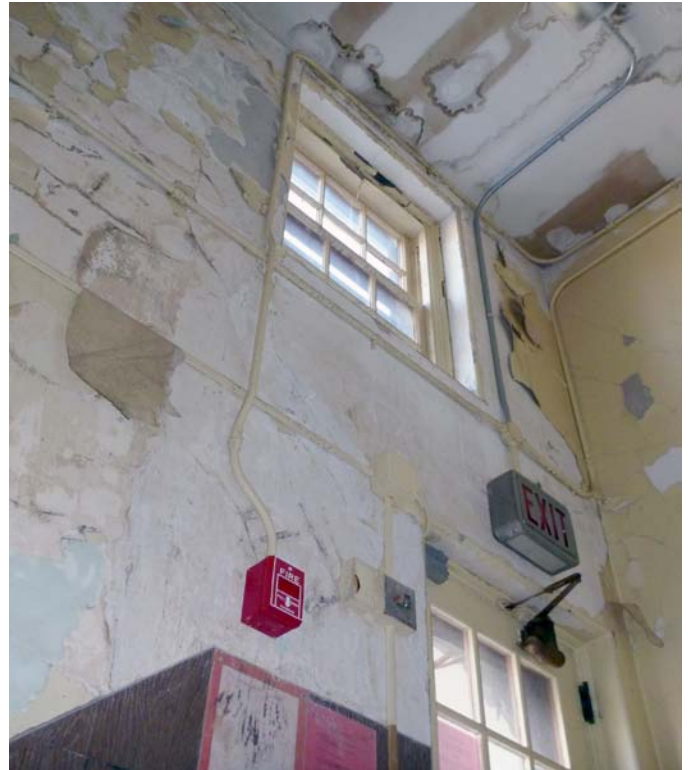
49 Water infiltration through foundation walls. Dirt and pollutants. Peeling paint.

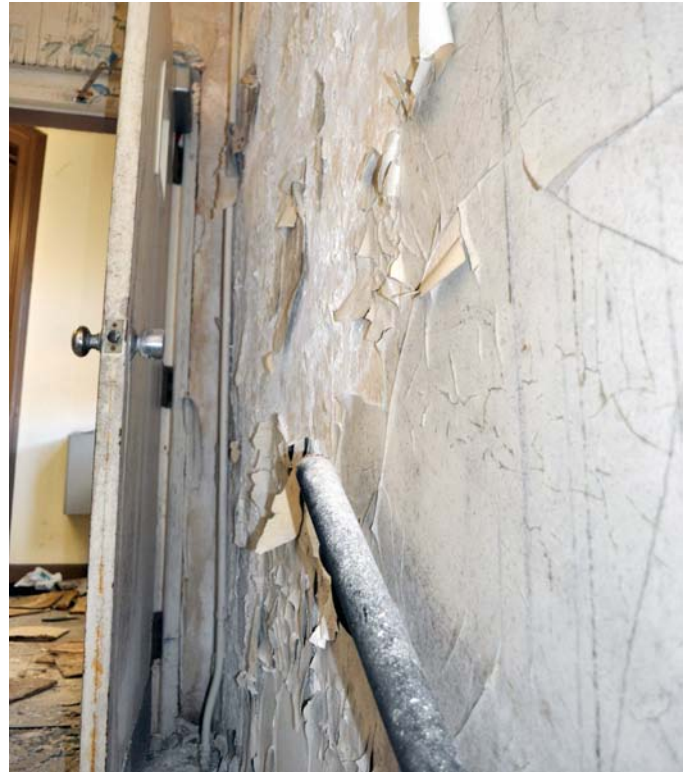
53 Peeling paint. Deteriorating plaster walls and ceilings.

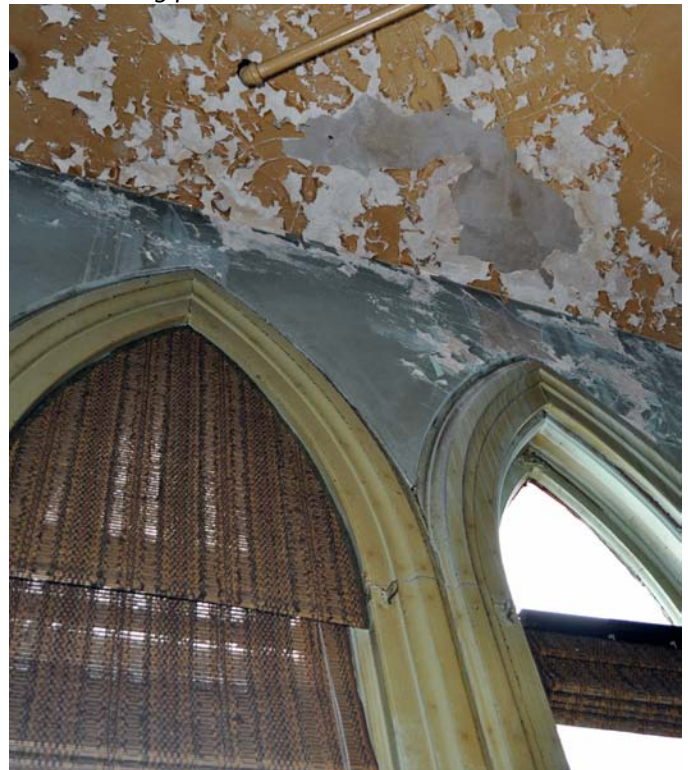
55 Water infiltration through ceiling. Dirt and pollutants. Peeling paint. Deteriorating acoustical ceiling and floor tiles.

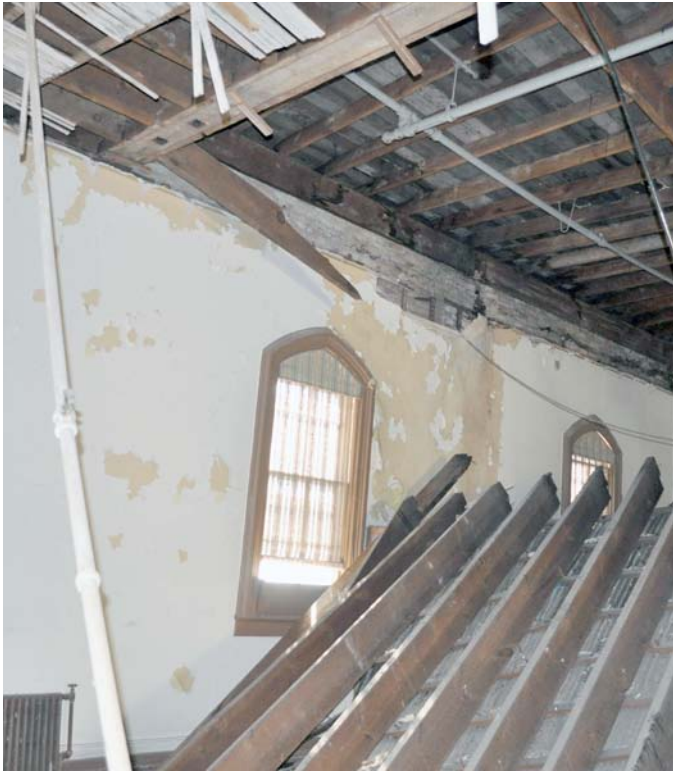
56 Water infiltration through ceiling. Dirt and pollutants. Peeling paint. Deteriorating plaster.

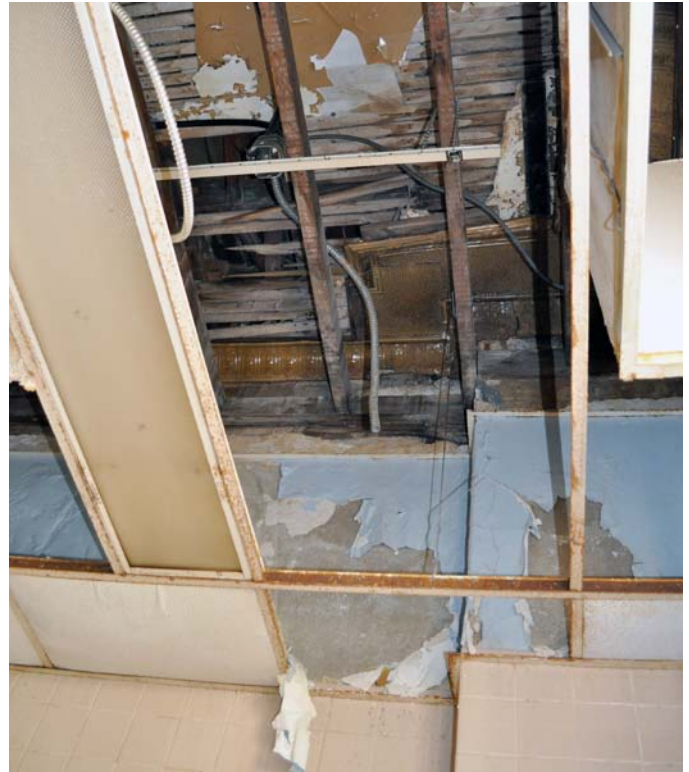
57 Ceiling collapse due to structural failure. Water infiltration through roof. Peeling paint.

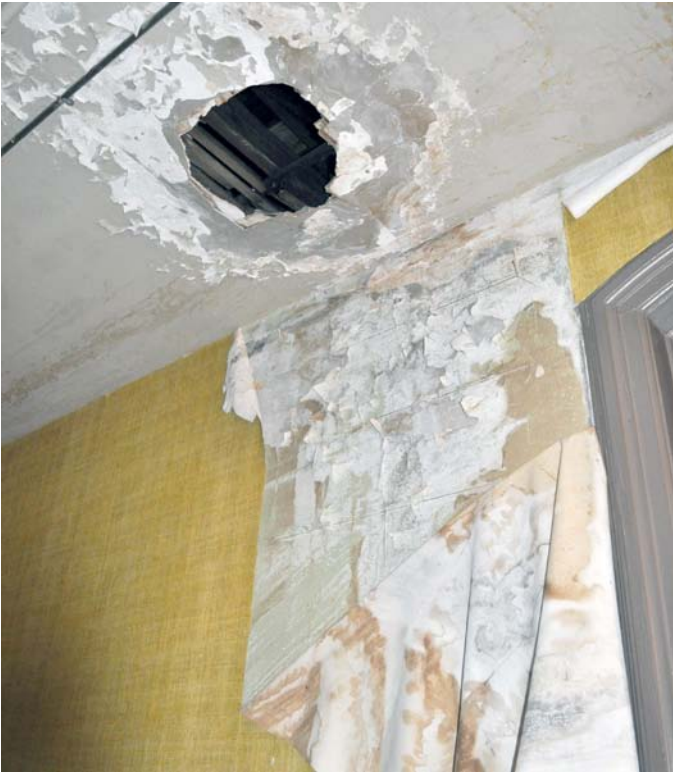
60 Peeling paint from tin ceiling, walls and wainscot.

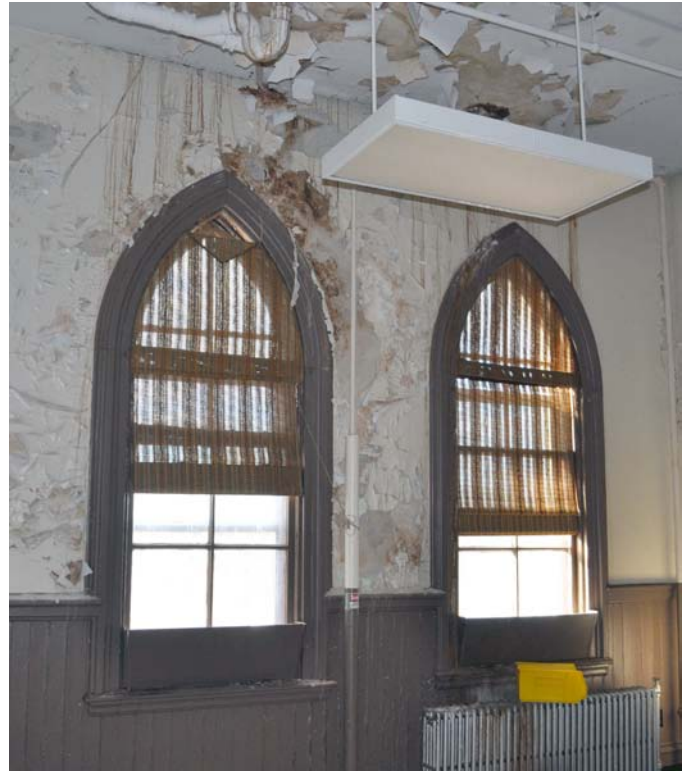
61 Water infiltration through ceiling. Dirt and pollutants. Deteriorating plaster. Peeling vinyl wall covering.

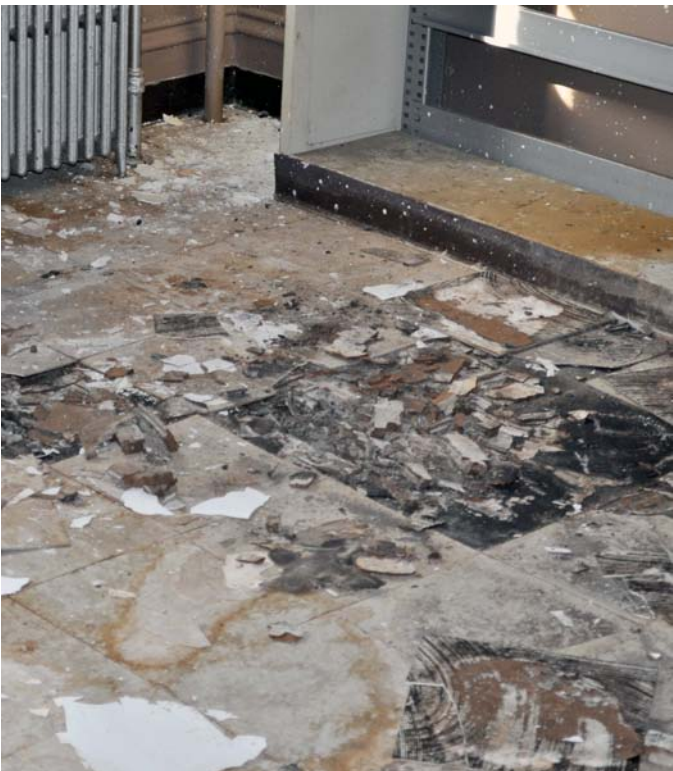
62 Water infiltration through ceiling. Dirt and pollutants. Peeling paint. Deteriorating plaster.

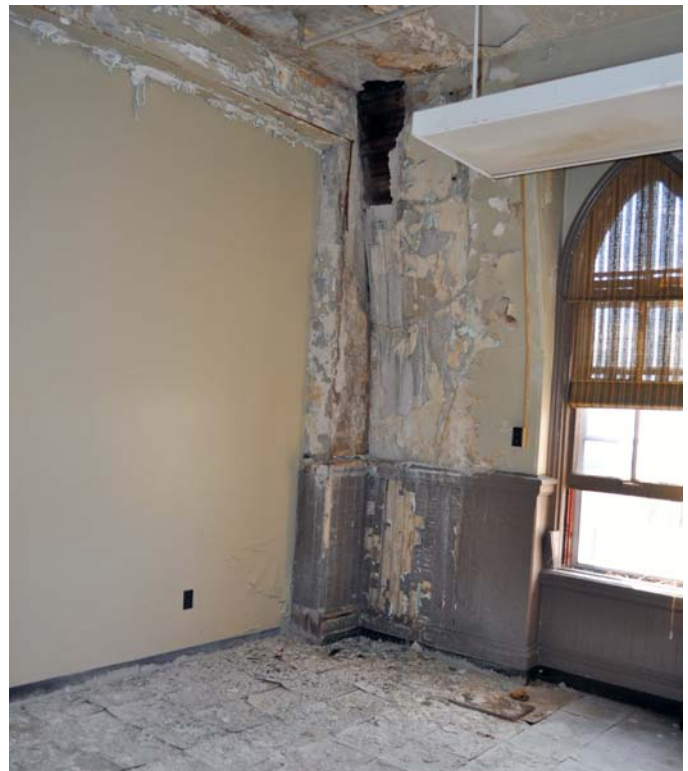
63 Water infiltration through ceiling. Dirt and pollutants. Deteriorating vinyl floor finish and wood floor boards.

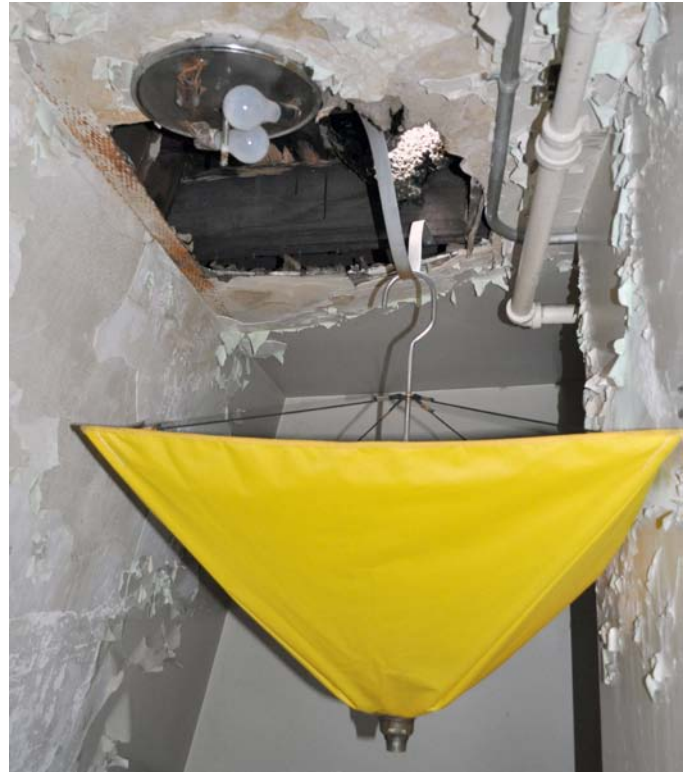
65 Dirt and pollutants on floors, walls, and ceilings. Demolished toilet room with missing fixtures.

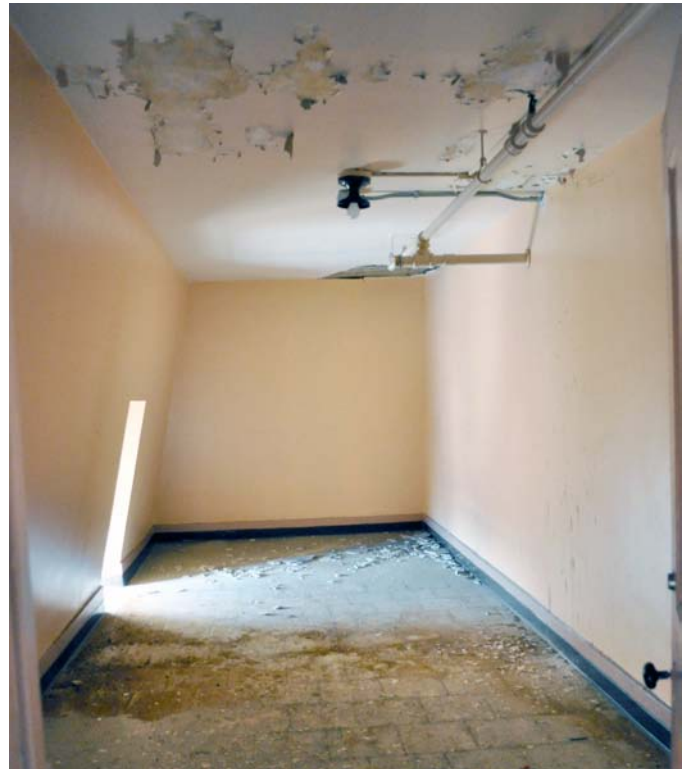
71 Dirt and pollutants. Peeling paint. Partially demolished non-handicap accessible toilet room.

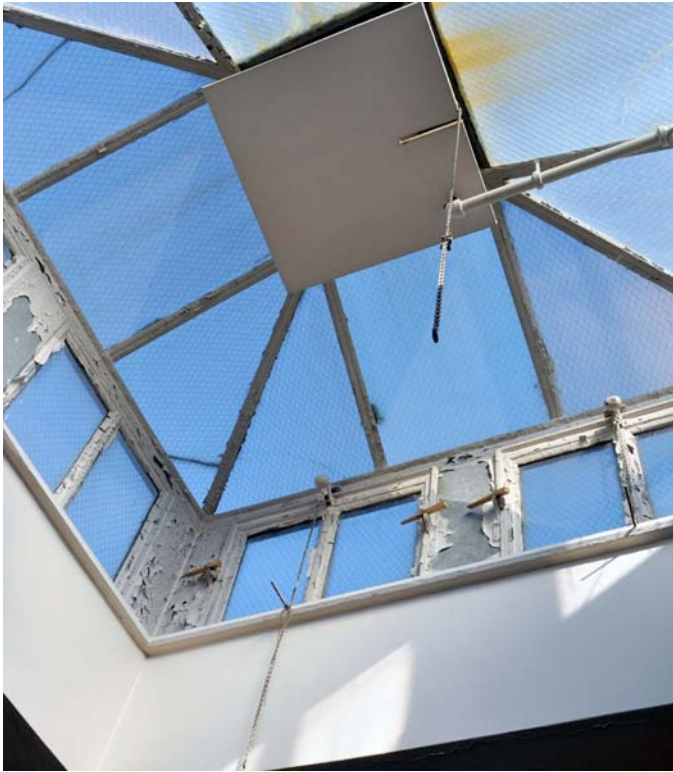
72 Dirt and pollutants. Peeling paint. Water damage on ceiling and floor.

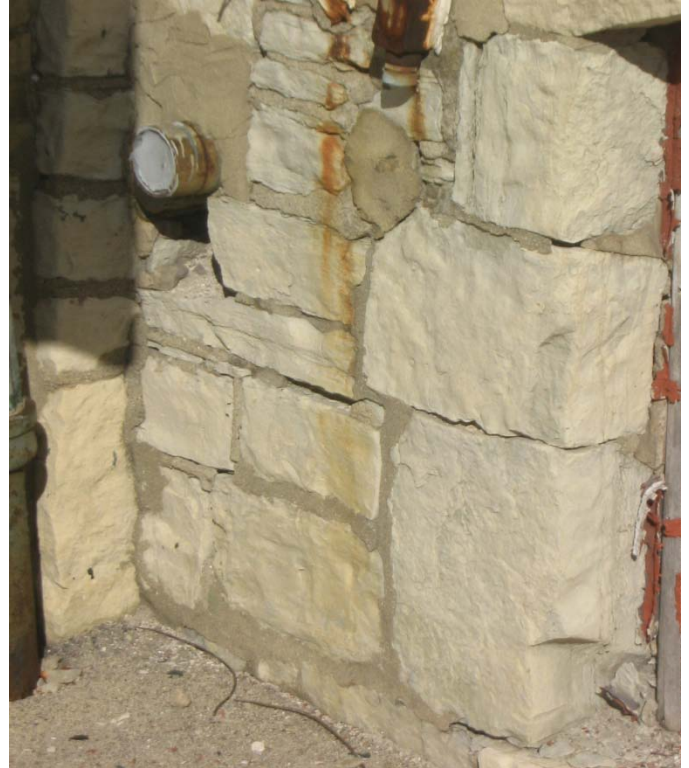
Photo 1: Deterioration & Cracking at Existing Masonry Foundation Walls.

Re-pointing of all existing masonry stone walls where cracking and deterioration has occurred should be addressed in the near future. Cleaning & removal of the surface deterioration that is currently present would also be recommended. All loose and missing stone should be removed and replaced with new to match existing.

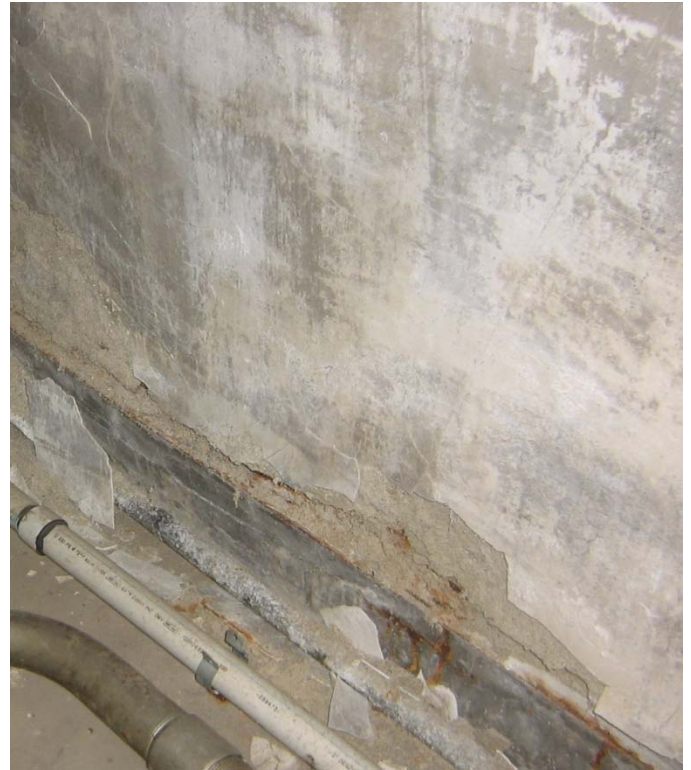
Photo 9: Deterioration & Cracking at Existing Concrete Floor Slab.

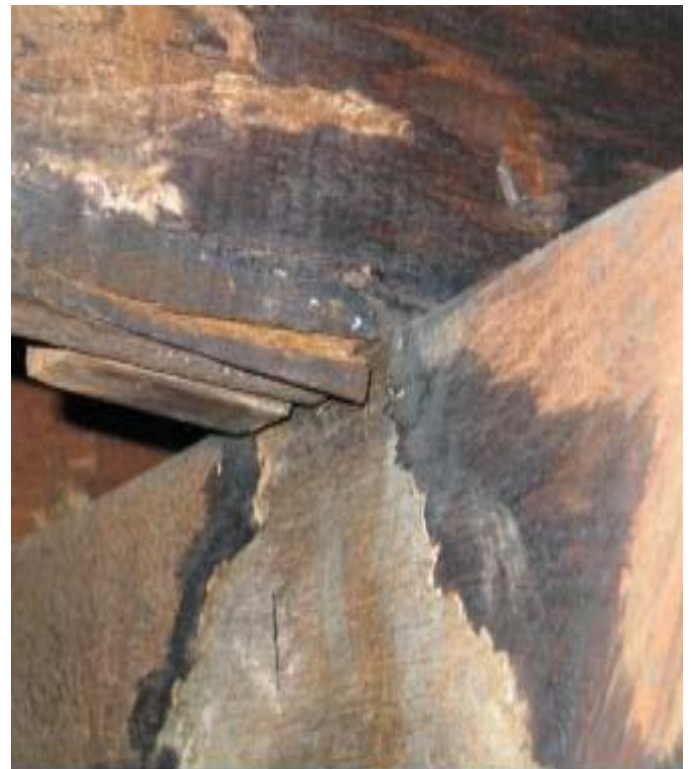
Photo 11: Deterioration & Warping of Existing Wood Floor Beam & Associated Floor Framing.

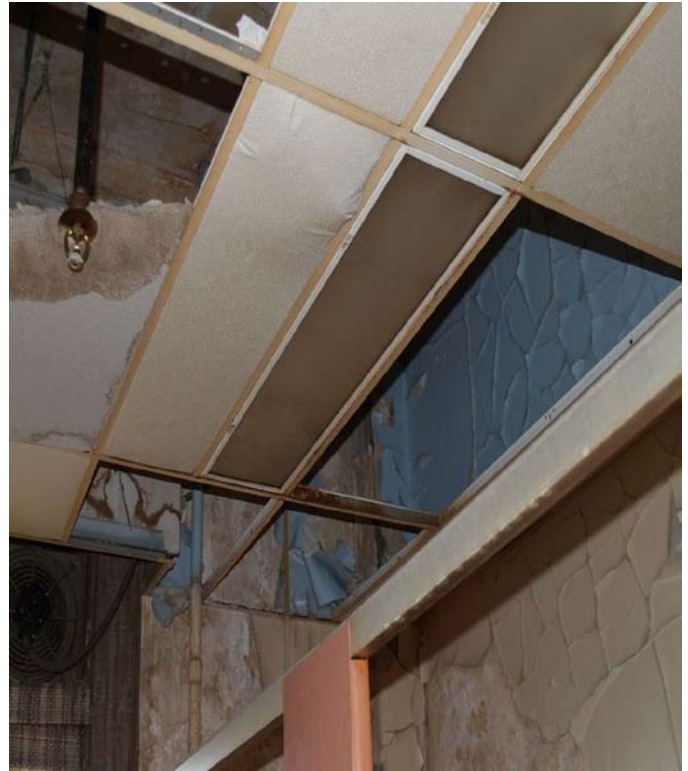
9 *Peeling paint and moisture water infiltration on second floor*

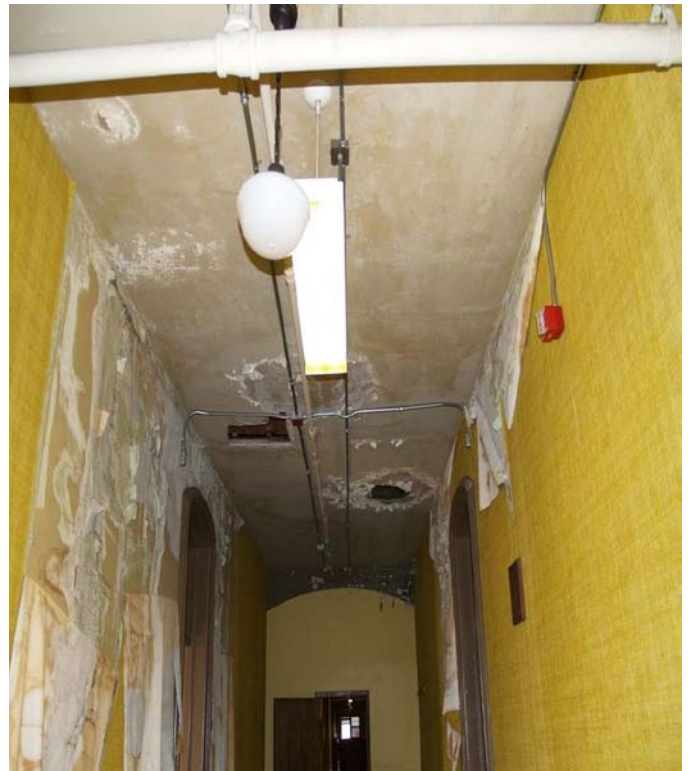
15 *Peeling paint and water damaged plaster on third floor*

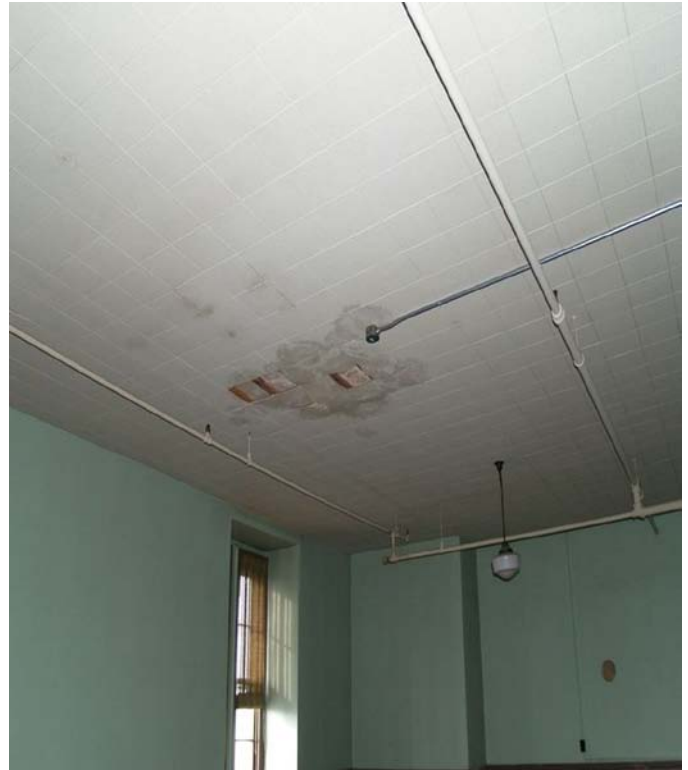
17 Peeling paint and water damaged plaster on third floor

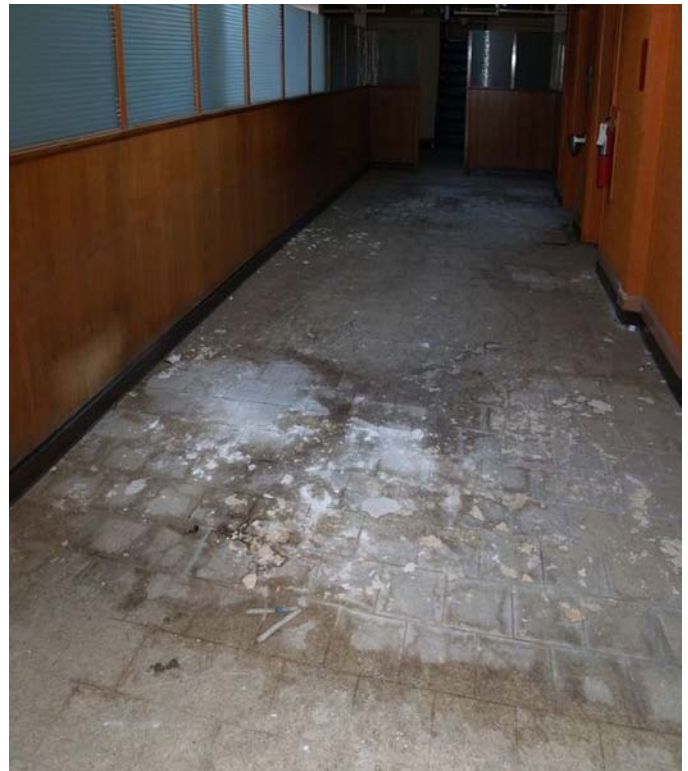
19 Water damage adjacent to skylight on fifth floor
